Inspection of the TRIGA Reactor Tank

Jernej Jerman

Andrej Lešnjak¹, Luka Snoj², Borut Smodiš²

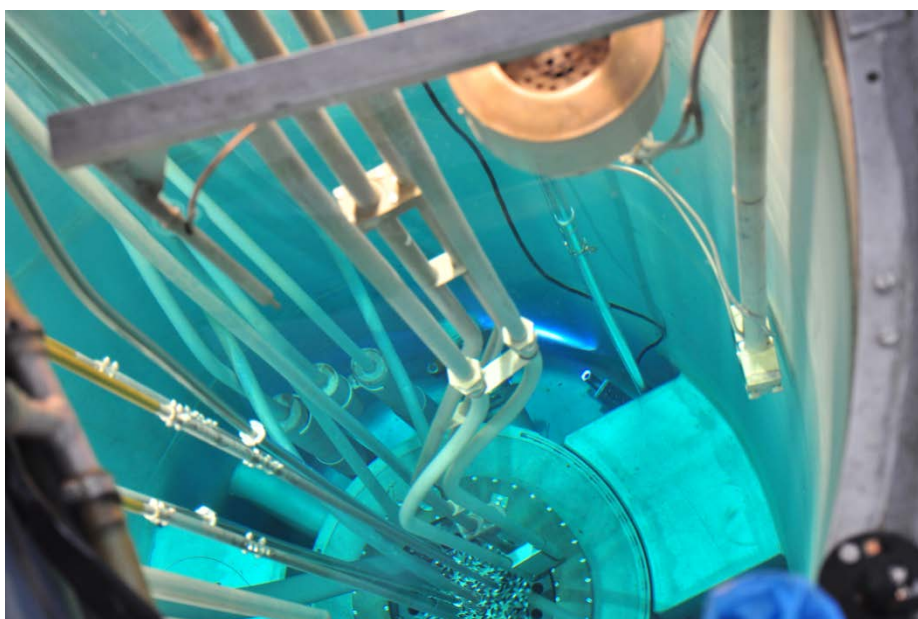
Figure 5: Bottom of TRIGA reactors with different internals

The scanning path was planned in the advance. Inspection was done at levels all around the tank. The camera does not permit a very far view and for this reason much scanning was needed. The upper part is not so complicated relatively for inspection because there are not so many components and structures. At the bottom of the tank the situation is completely different. There are guide tubes, irradiation channels, nuclear instrumentation, fuel element storage racks, the reactor core, thermalising column, thermal column, pipes (thruports), etc. It can be seen in Figure 5 that the configuration at the bottom of the vessel is quite complicated for visual inspection.

During the inspection no degradation processes like cracks or major corrosion areas were observed. There were also no other indications like mechanical damage due to the fall of heavy loads or collision with a sharp hard object. On the bottom of vessel some small foreign material and small local corroded areas were observed. It is assumed that corrosion areas appeared from foreign material which had been removed from vessel in the past.

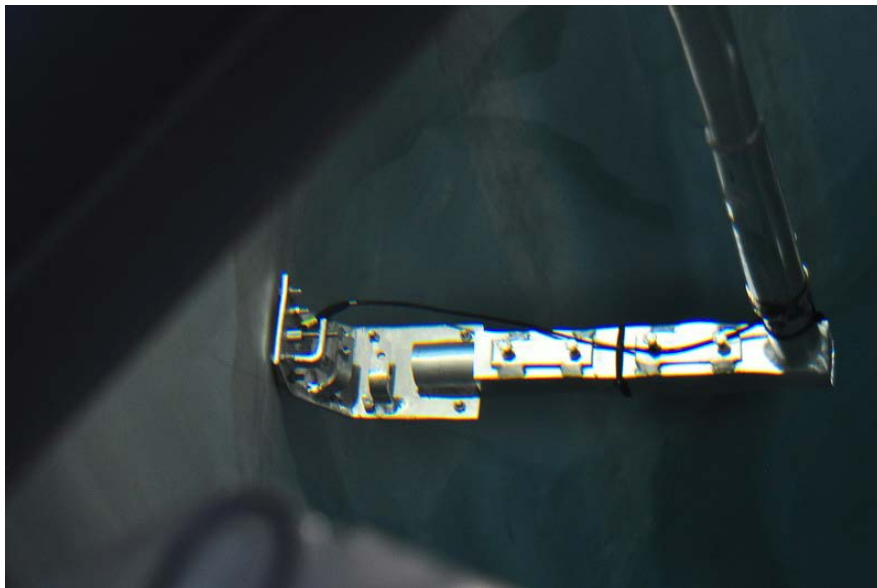
Figure 6: Ultrasonic probe

Locations where thickness was measured were positioned as a grid on the cylindrical and bottom parts. Thirteen measuring point were made in the longitudinal direction of cylindrical part 300 to 500mm apart, and eight divisions were made in the circumferential direction. The bottom was divided at four locations in the radial direction and the cylindrical part in eight divisions in circumference direction. Positions of measuring points were dependent sometimes on obstruction configuration in the vessel. Wall thicknesses of the cylindrical part were between 5.6 and 6.7mm and on the bottom 5.8 and 6.5mm, and no essential deviation from the nominal thickness was detected. Also in between the measuring points the thickness was scanned to discover any changes.
